## **KNOWLEDGE OF TRADITIONAL BUILDING METHODS TO SAFEGUARD AND PRESERVE THEM. EVOLUTION OF MASONRY TECHNIQUES IN VALENCIA CITY**

Camilla Mileto<sup>1</sup>, Fernando Vegas<sup>2</sup> and Valentina Cristini<sup>3</sup>

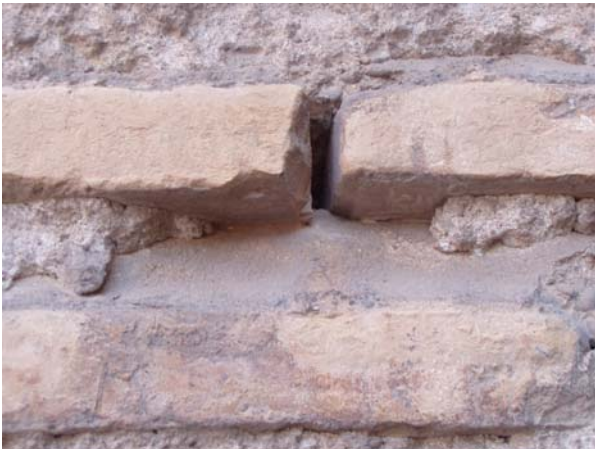
**Figure 2.** Communion Chapel of the Church de Santos Juanes (1644). Detail of *agramilado* method that shows the first layer of the joint and rests of the sealing second layer called *zaboyado*.

The importance of this building method called *agramilado* that seals the joints resides precisely in that it reduces the number of bricks used in the masonry. In fact, the joint is practically the same thickness as a complete row of bricks. Analyses with an optic microscope revealed a first layer of lime mortar with quartz sand in a 1:1 proportion (quartz 47%, lime 46%). A small amount of gypsum and feldspar was also detected.

It is a semi-opaque treatment with lime and red ochre, a pigment with an iron oxide base that can be painted over in order to regularise the joints with geometrical precision. This method is used in the case of fabrics with medium horizontal joints (30-37 mm), slightly thinner vertical joints (20-25 mm) and rather thick bricks (40-45 mm). It is interesting to note that this technical solution, linked to academicist cultural trends in the second half of the 18<sup>th</sup> century, arrived on the scene after the *agramilado* method. This method enriches the range of possible opaque treatments of walls, thus improving and completing the stereometry and uniformity of the surfaces.

The presence of gypsum helped accelerate the carbonation process and the feldspar appeared as a result of the precipitation of alum, a type of potassium sulphate used as a consolidant of the mixture. On the other hand, the second layer called *zaboyado* has a simpler composition, without complex minerals, made up only of lime and aggregates in 1:1 proportion (lime 57%, quartz 43%).

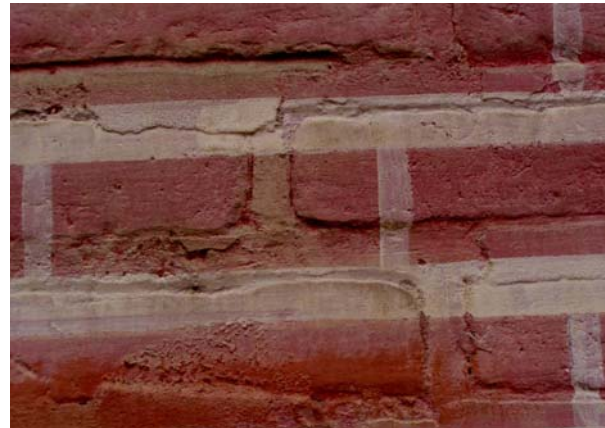
**Figure 3.** Aduana Palace- 1758-70. Detail of the original fake brick wash and the recent restoration (1996-1997)

Another extremely interesting technique in the characterisation of Valencian building methods is the fake brick wash or *tingido de ladrillo* (See Figure 3). It is a finish that covers less than a simple layer of rendering.

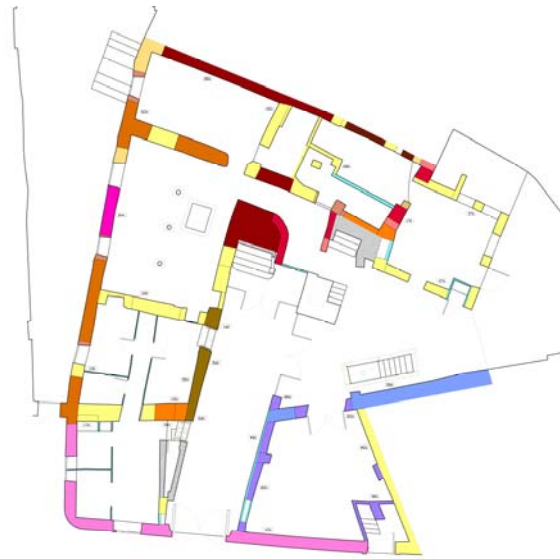
**Figure 4.** Marqués de Caro Palace. Layout of the ground floor with the type of fabrics found shown in different colours

In the case of *lime-coated clay pisé-de-terre*, there are three different types: pisé-de-terre that still bears the original lime finish with a smooth surface produced by the moulding; pisé-de-terre without its surface finish, showing only the clay nucleus with thin layers of lime; and lime and gravel pisé-de-terre poured in some areas to reinforce or level the existing wall. This

technique can be seen in the remains of the Islamic wall to which the first building was attached between the 15<sup>th</sup> and 16<sup>th</sup> centuries and which was expanded on successive occasions until it reached its current configuration.

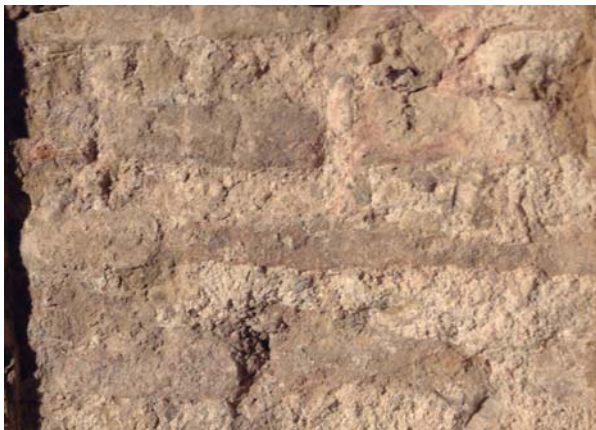
**Figure 5.** Detail of brick-reinforced pisé-de-terre techniques

There are two main types of brick-reinforced pisé-de-terre techniques: the first, probably dating from the 15<sup>th</sup> or 16<sup>th</sup> centuries, with a very fine-grained surface crust that denotes a painstaking surface finish to be left naked (See Figure 5); and the second, perhaps an imitation of the first made in an extension of the building carried out in the early 19<sup>th</sup> century, with a very thick-grained surface crust probably not intended to be left bare, or for less important areas of the palace.

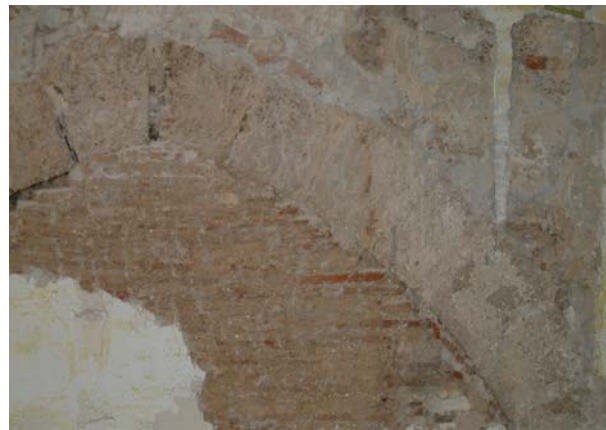
**Figure 6.** Ashlar arch subsequently filled with brick fabric

There are few examples of *ashlar fabric*, which is only to be found in the two large arches on the ground floor of the house (See Figure 6), and *masonry fabric*, also only present on the ground floor and often used as a socle to place brick fabrics on top, to prevent the capillary action of rising damp.

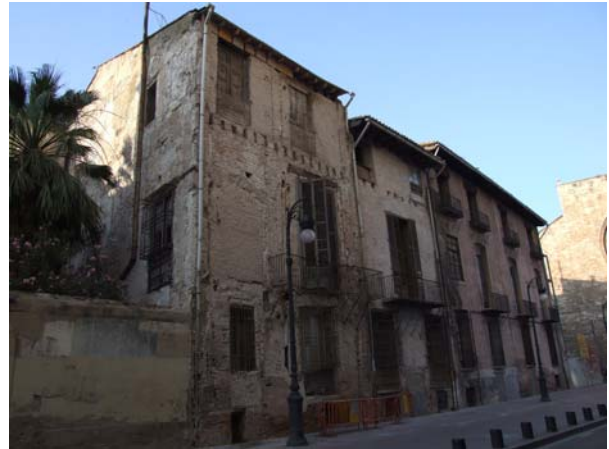
**Figure 7.** Rear facade of the Calle Exarchs palaces

Another very interesting case to help understand the building methods used in Valencian brick fabrics is the palaces located in Calle Exarchs (See Figure 7). There is a row of noble palaces probably erected between the 15<sup>th</sup> and 16<sup>th</sup> centuries (Simó 1983) but transformed in the 18<sup>th</sup> century. By pure chance, these buildings were spared from demolition in the mid 20<sup>th</sup> century when the new course of the Avenida Barón de Cárcer was to go right over the place where these buildings stood. However, these demolitions stopped just before reaching these palaces, thus saving one of the few precious samples we have of 18<sup>th</sup> century Valencian architecture.

The row of houses is formed by four palaces, of which only the first three, located respectively at numbers 3, 5 and 7, occupy the whole depth of the site with their main facade looking on to Calle Exarchs and their back facade giving on to Calle Belluga. These three buildings represent a real jewel in the architecture in the historic centre of Valencia between the 15<sup>th</sup> and 18<sup>th</sup> centuries, although ignorance of their existence has reduced them to a shameful state of neglect and disrepair.

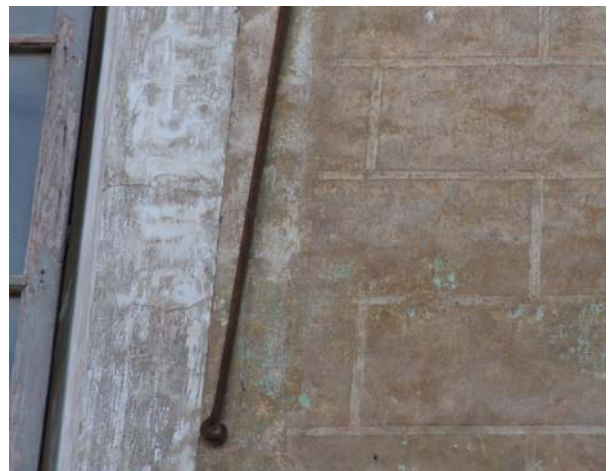
**Figure 8.** Detail of the treatment of *false ashlars* on the palace main facade

The three buildings, made principally of brick fabric –some traces of brick-reinforced pisé-de-terre can still be seen at the top of the common wall of the palace at number 5– conserve on their facades some rare samples of the finish usually given to facades in the 18<sup>th</sup> century. In the case of the palaces situated at numbers 5 and 7 of Calle Exarchs, the original rendering is still conserved on the main facade (See Figure 8): a continuous lime coating with *false ashlar* where the edge of the joints are decorated with sgraffito and the joint bears a white wash to make it stand out against the yellow imitation-stone background.

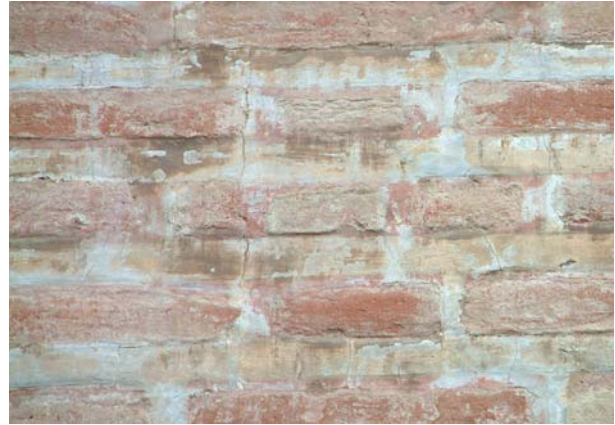
**Figure 9.** Detail of the *fake brick wash* treatment on the palace rear facade

was obviously used to dignify the main facade of the palace. The back facades of this row of palaces clearly show the intention of creating a distinction between the front and back facades. The palace situated at Calle Exarchs number 3 has the best-conserved back facade with a *fake brick wash* treatment, one of the best-conserved examples of this sort of facade in the city (See Figure 9).

The fake brick wash technique is applied to facades to cover up brick fabric when it is not sufficiently regular. This method represents regular bonding by scratching the edge of the joint between bricks and colouring the joint with whitewash and the bricks with red ochre. In spite of the passage of time, the palace facade still conserves the characteristic chromatic contrast of this treatment, which was not only used to embellish the building but to protect the fabric, often made of poor-quality brick.

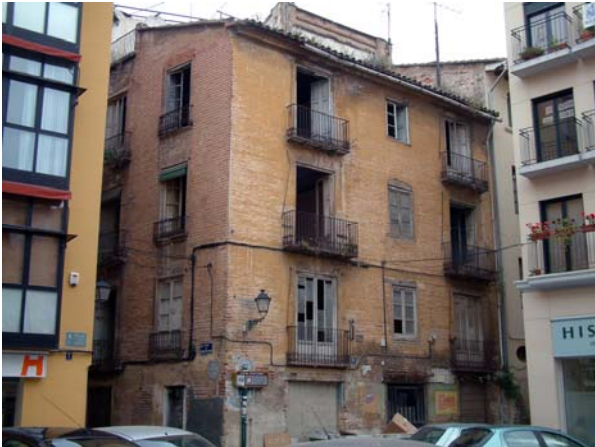
**Figure 10.** Raga House in the Plaza del Pilar of Valencia

In Casa Raga, located in the Plaza del Pilar in the Velluters district in Valencia (See Figure 10), the authors of this text had the opportunity to study and draw up a restoration project (Mileto, Vegas & Calabuig 2005) for a building that still boasts historic finishes on its exterior facades, which have not been eliminated in spite of refurbishment works. It is a building in the very heart of the city, first built in the end of 17<sup>th</sup> century and later expanded and altered in two interventions performed in the mid 19<sup>th</sup> and early 20<sup>th</sup> centuries.

Both the first construction of the building and the posterior expansion and refurbishment works were made with traditional local methods. The apparently homogeneous brick walls of the building have recorded all the interventions practiced over the years. The building

technique used initially was a load-bearing brick wall with lime mortar joints. The finish of the surface was made by covering the joint with a finer lime mortar to protect the structural joint and painting the bricks with red ochre to augment the red colour of the brick (See Figure 11).

This finish typical of 17<sup>th</sup> and 18<sup>th</sup> century Valencian architecture, is conserved on most of the facade giving on to the square and the corner of Calle Roger de Flor. The building was restored in the mid 19<sup>th</sup> century. A new part was added on the side looking on to Calle Roger de Flor and the interior layout was changed, which involved opening some new bays in the facades.

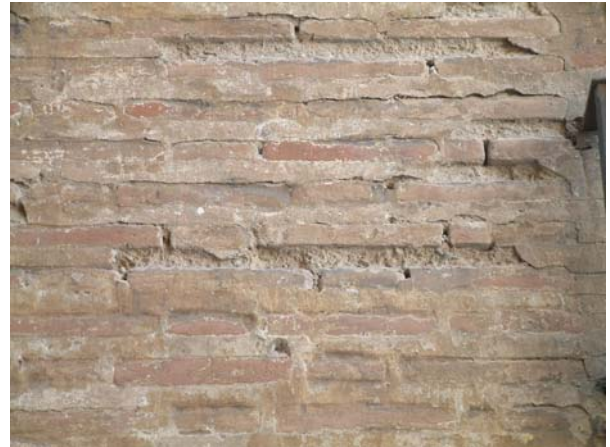
**Figure 11.** Detail of the facades' original treatment

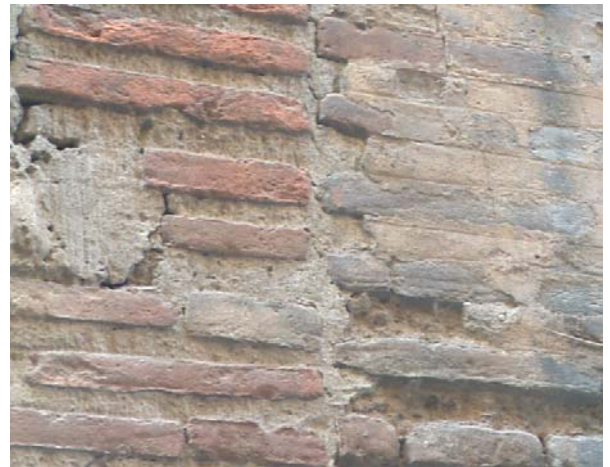
**Figure 12.** Imitation of the original treatment made during the intervention of 19<sup>th</sup> century

The surface of the facade conserves the traces of this intervention. The fabric was rebuilt around the altered or added bays imitating the original fabric (See Figure 12): the same brick was maintained in an attempt to respect the original rows, but the fabric can easily be distinguished because of the gypsum mortar used.

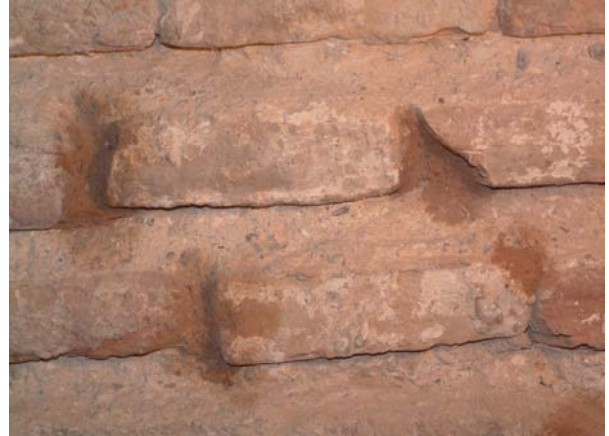
**Figure 13.** Selective rejoining made only in the vertical joints

Another type of essay consisted of a selective rejoining of the fabric. The loss of material in the joints of a brick fabric is inconvenient for its conservation because it lets water seep in and freezing and thawing can damage the fabric. Nevertheless, complete rejoining of the fabric, as we said above, endangers its conservation as a historical document and a source of messages. Therefore in this and other cases (Mileto & Vegas 2005, 1; Mileto & Vegas 2006), selective rejoining was carried out on the places where material was missing without covering the existing joints (See Figure 13 and 14). This way of mending the fabric entails a satisfactory level of consolidation and protection and ensures the decorum of the facade conserving, at the same time, the conservation of the building's character and entity as a historic document.

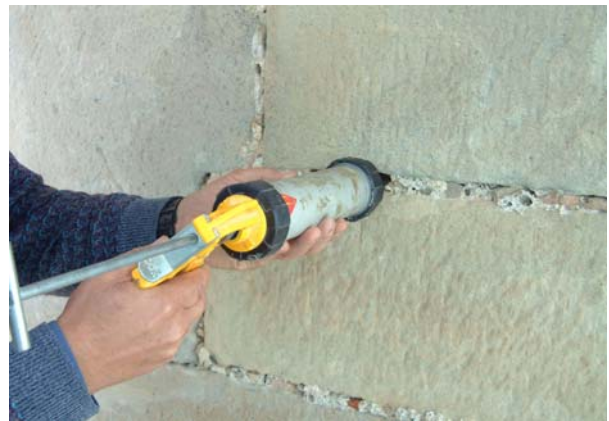
**Figure 14.** Application of a selective rejoining
