## Core, connectors and crust: Methodological restoration options for reinforced rammed earth wall with bricks

V. Cristini & J.R. Ruiz Checa

Universitat Politècnica de València, Valencia, Spain

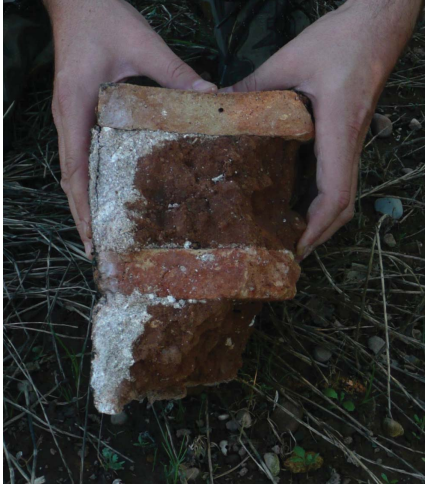
Figure 2. Mortar core, ceramic connectors and crust. Three detached parts of a *tapia valenciana* wall. (Authors: Cristini & Ruiz Checa).

the heterogeneity of the raw materials is not unintentional. In this case, the bricks' function is more that of connecting the strata rather than traditional brickwork masonry. Because of this, it is possible to identify three detached and well defined parts that form a *tapia valenciana* wall: a rammed earth and lime mortar core, a few ceramic connectors and finally a lime crust (Fig. 2).

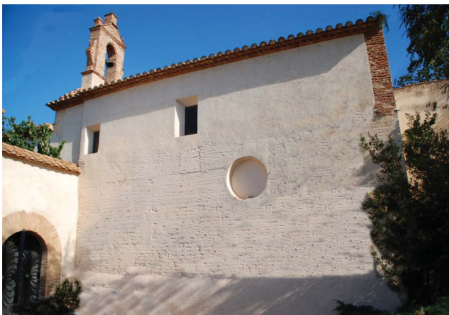
Figure 4. Whitewashed surface of *tapia valenciana* wall, *Ermita de S. Jaume de Fadrell*, Castellón (Authors: Cristini & Ruiz Checa).

After the interventions, the majority of the analyzed walls reveal processes carried out mainly in the crust. Many of the cases deal with plasters, anti graffiti treatments, or coatings that distress on the walls’ “surface of sacrifice”, and replace or cover the original surface (Figs. 4–5). A few cases display simple epidermis consolidation, in order to avoid micro-fissures and discontinuities, thanks to jointing processes.

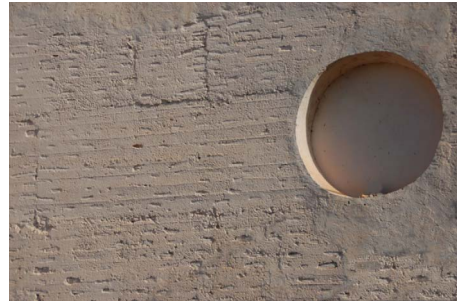
Figure 5. Whitewashed surface detail, *Ermita de S. Jaume de Fadrell*, Castellón (Authors: Cristini & Ruiz Checa).

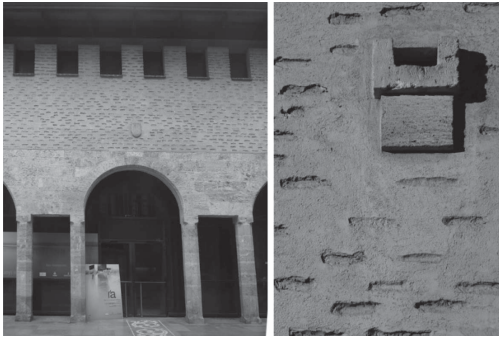
Figure 6. A surface detail, simulating header bricks. *Almudín*, Valencia (Medieval Granary) (Authors: Cristini & Ruiz Checa).

Moreover, in some cases, the original wall texture displays new renderings that simulate the primitive wall bond, which they aspire to, with more or less successful results. Some contemporary interventions have featured stencil decoration and graphic images, in search for abstract plans that recall and simulate the header bricks (Figs. 6–7).

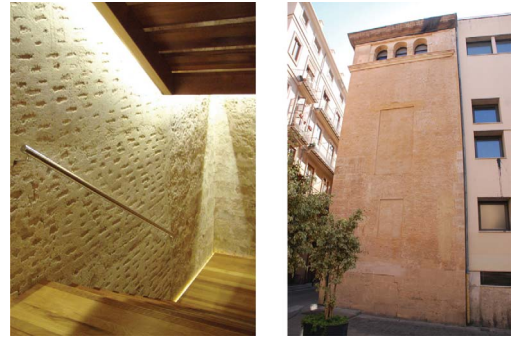
Figure 8. Core and surface interventions: *Alaquás Castle*, Valencia and *Palacio d'en Bou*, Valencia (Authors: Cristini & Ruiz Checa).

On the other hand, interventions in the core are less common. The depth of this type of intervention in itself signifies the need for a change in approach; these types of interventions need to be considered as volumetric reconstructions. Undoubtedly a huge loss in percentage of historical wall is inevitable in these cases, often rebuilt solely with mortar without brick connectors.

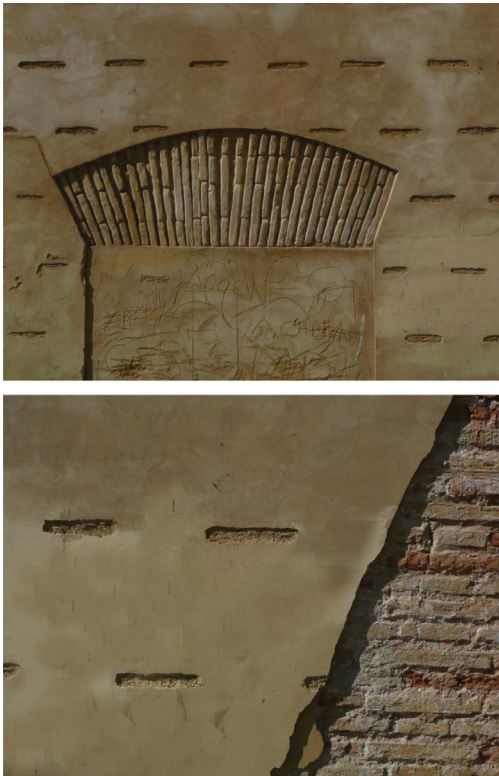
Figure 7. A surface detail, simulating header bricks. *Palacio del Gremio de Carpinteros* (Ancient Carpenters' Trade Centre) (Authors: Cristini & Ruiz Checa).
