Constructive features and preservation work of rammed earth architecture: the Islamic tower of Bofilla (Valencia)

The Bofilla tower (Valencia, Spain), at 800 years old one of the oldest buildings still standing in the whole region, is a rubble-reinforced rammed earth construction almost 20 m high. Its precarious condition called for preservation works and the enhancement of the surrounding archaeological site. However, these works involved a serious risk that the original construction might lose its hallmarks and its history, which had great narrative potential, due to the plasticity of the earth. Furthermore, as often happens, a great deal of the character and antiquity of the tower were linked to the erosion and abrasion of its rammed earth surfaces, so it was necessary for the preservation to try to alleviate or stop the degradation that threatened the tower's survival and, at the same time, conserve its narrative potential, its aura and its ancestral character. After performing a comprehensive preliminary study of the construction and its state of repair, a large number of preservation tasks were carried out, from cleaning the façades by hand to reconstructing the structure of

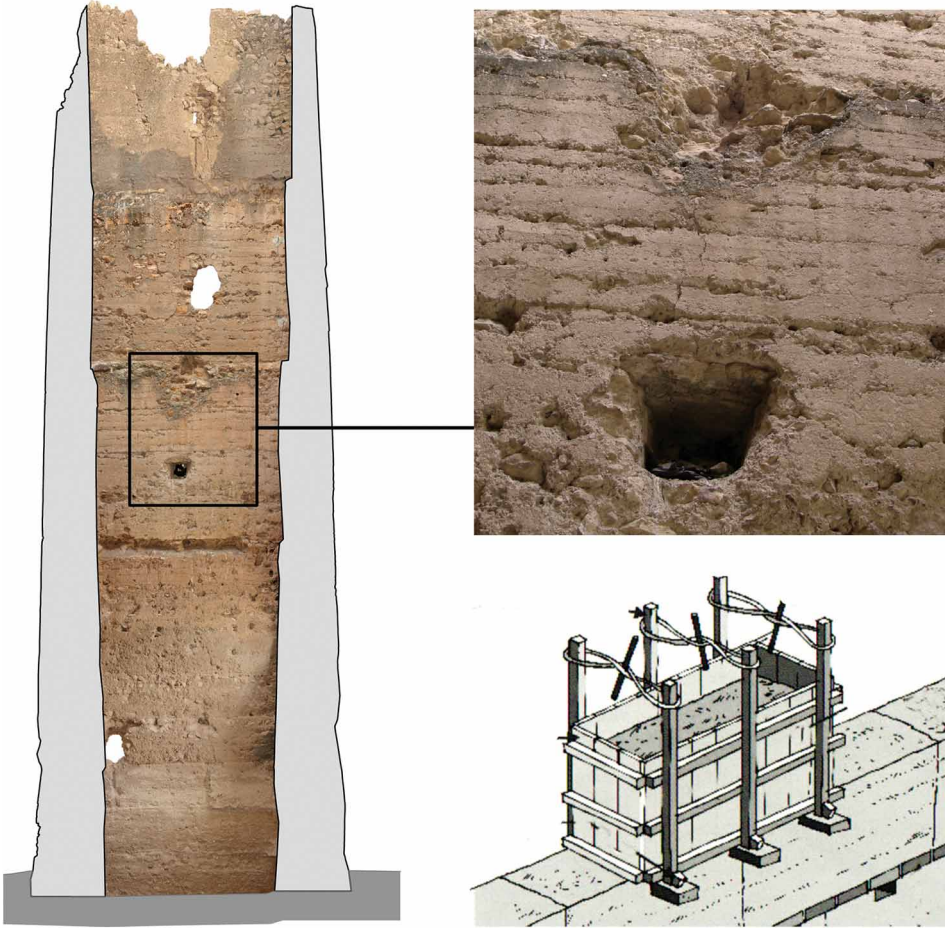
Figure 2. Detail of the masonry of watchtowers: rammed earth walls enriched with lime and internal stone filling (Vegas & Mileto).

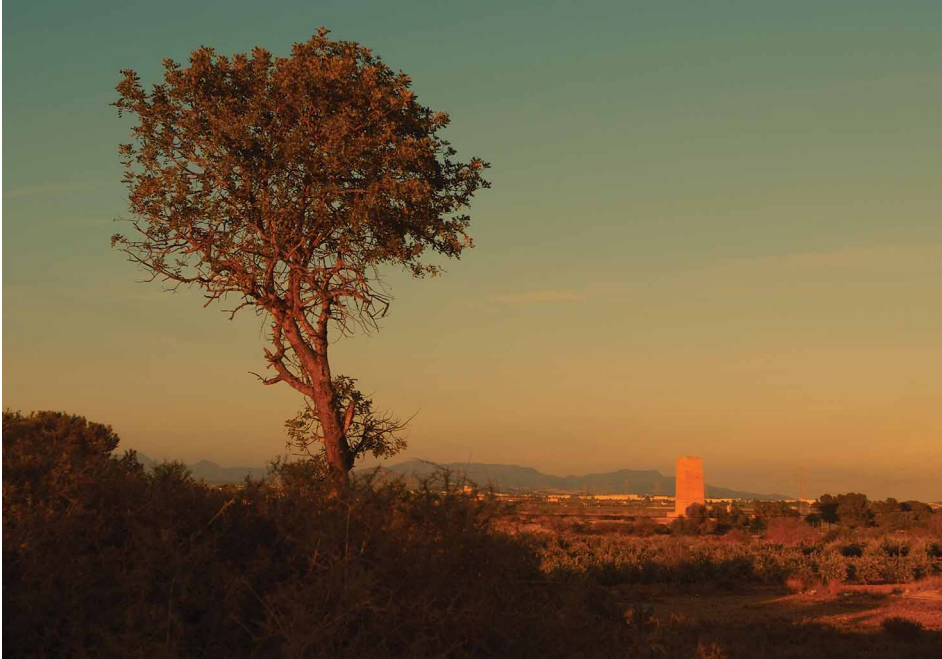
Given the lack of documentation about the building, before the previous study regarding the preservation of the Bofilla tower in Bétera it was presumed that the tower had been erected during the twelfth century, associated with a surrounding village (Figure 3). The tower was used by Islamic settlers up to 1238, the year of the Christian Reconquista of Valencia. After this it was used by

Figure 3. Bofilla tower and its surroundings (Vegas & Mileto).

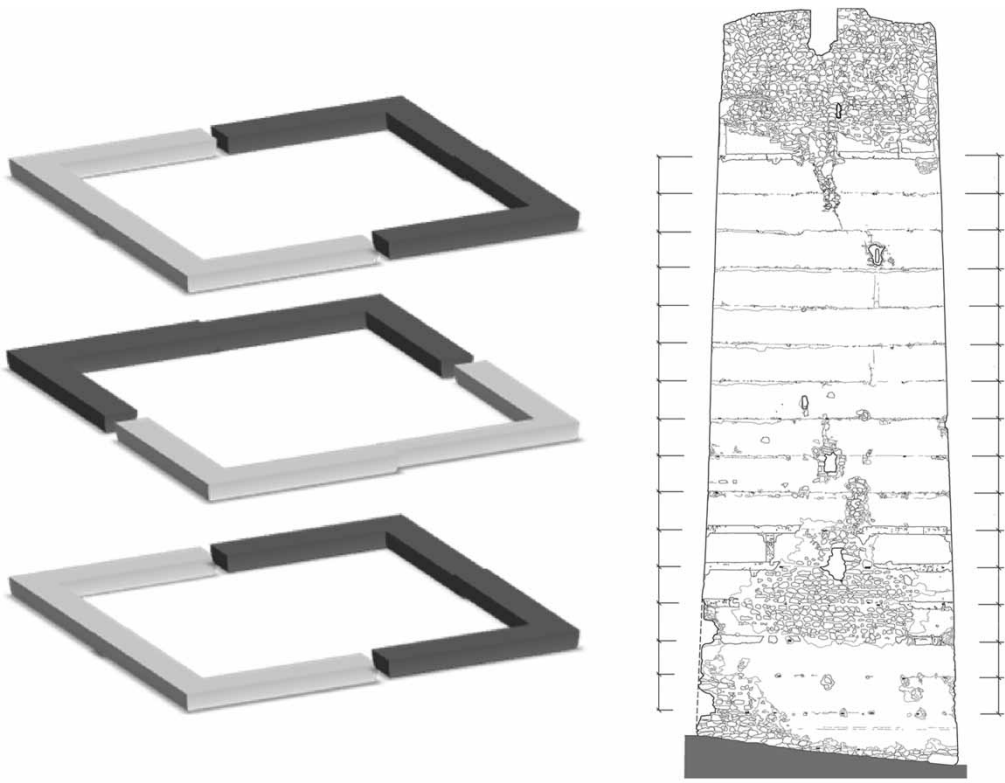
Figure 5. U-shape construction section alternated per each rammed earth course (Vegas & Mileto).

This circumstance demanded the construction of two sectors with a U-shape per each rammed earth course, alternating this discontinuity in height required turning the U-shaped modules in order to avoid vertical discontinuity at the front (Figure 5). In this way the joints, with their typical 60° incline, were alternated in the successive courses of the tower, excluding some exceptions in which two and even three courses were built one after the other in vertical continuity.

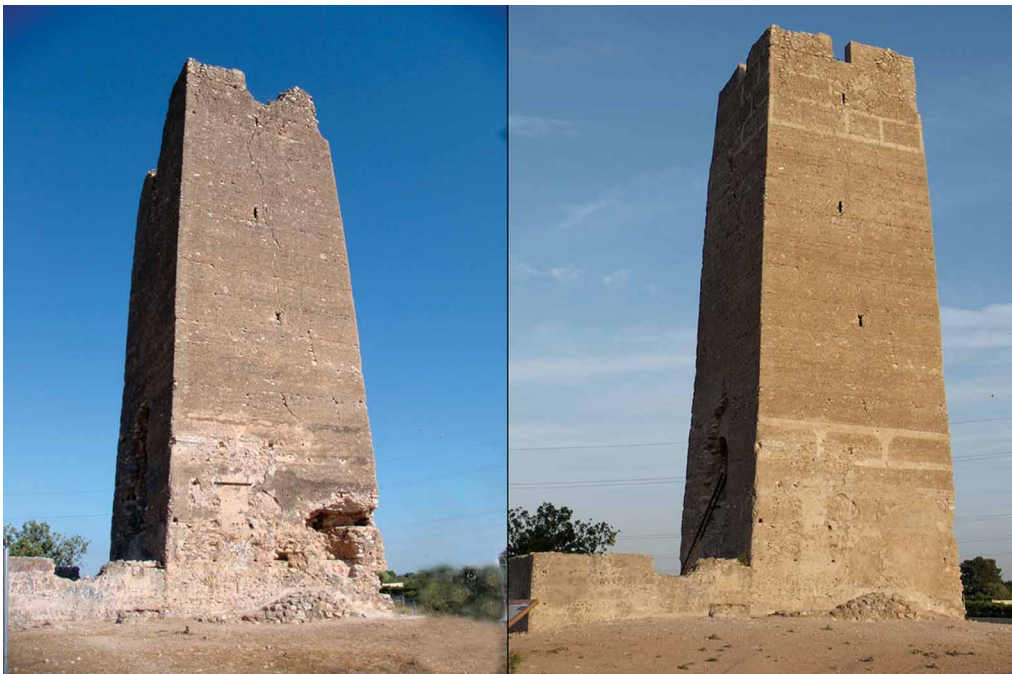
While it was in a nearly complete state, the tower was in a precarious condition (Figure 6), translated into the following phenomena:⁹

- General erosion of the bottom and top parts of the southern wall of the tower, where stone fillings from the interior mass appeared in the eroded surface.
- The existence of a large access hole at the south-eastern corner, with dimensions great enough for a man to get through. It also allowed access to the first level of the tower, placed at four rammed earth courses, or 3.60 m, from the land.
- Disappearance of the ashlar portal, which caused the partial collapse of the interior vertical parameter to the point of the coping of the building and a large breach on the external side.
- Disappearance of the historic wooden floors, parapet walls and machicolations, from which there are some remains inside the openings held by the earth mass, which are evidence of their genuine character, coetaneous to the erection of the tower.

Figure 6. The tower, after and before preservation works (Cristini).

- Major degradation of the coping of the tower, with the appearance of eroded crests and collapsed sections, particularly on the northern façade, over the entrance.
- Partial disappearance of the strips rendered with mortar rich in lime, as a result of erosion and putlog holes practised to accommodate some auxiliary construction, probably in the Christian age.
- Dirt and presence of lichens all over the surface of the four façades of the tower, especially on the northern and western walls.

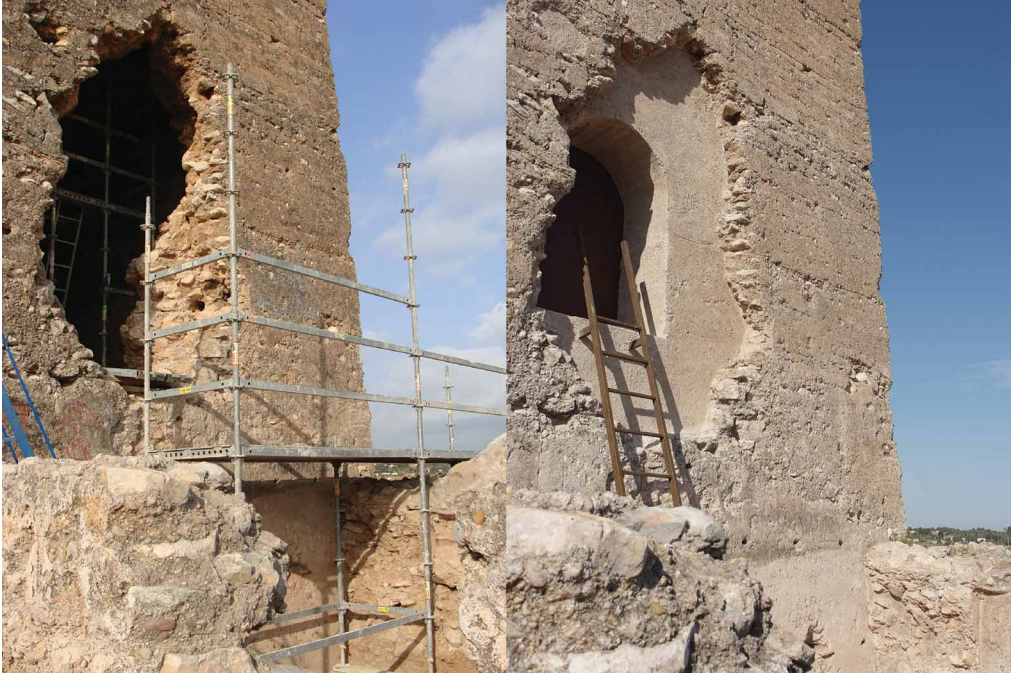
Figure 7. Reintegration works respecting the detail without having an impact on the overall view of the building (Cristini).

Once the cleaning of all surfaces was completed, the missing parts were reintegrated observing the original colour, intonation and vibration of the historic surface. For that aim, hydraulic lime mortar was used, mixing Saint-Astier hydraulic lime NHL 3.5 with river gravel with heterometric characteristics in 1/3 proportion. Given that the closest gravel to the original came from a quarry situated 300 km from the site, and considering the need to harmonize the reintegrated gaps

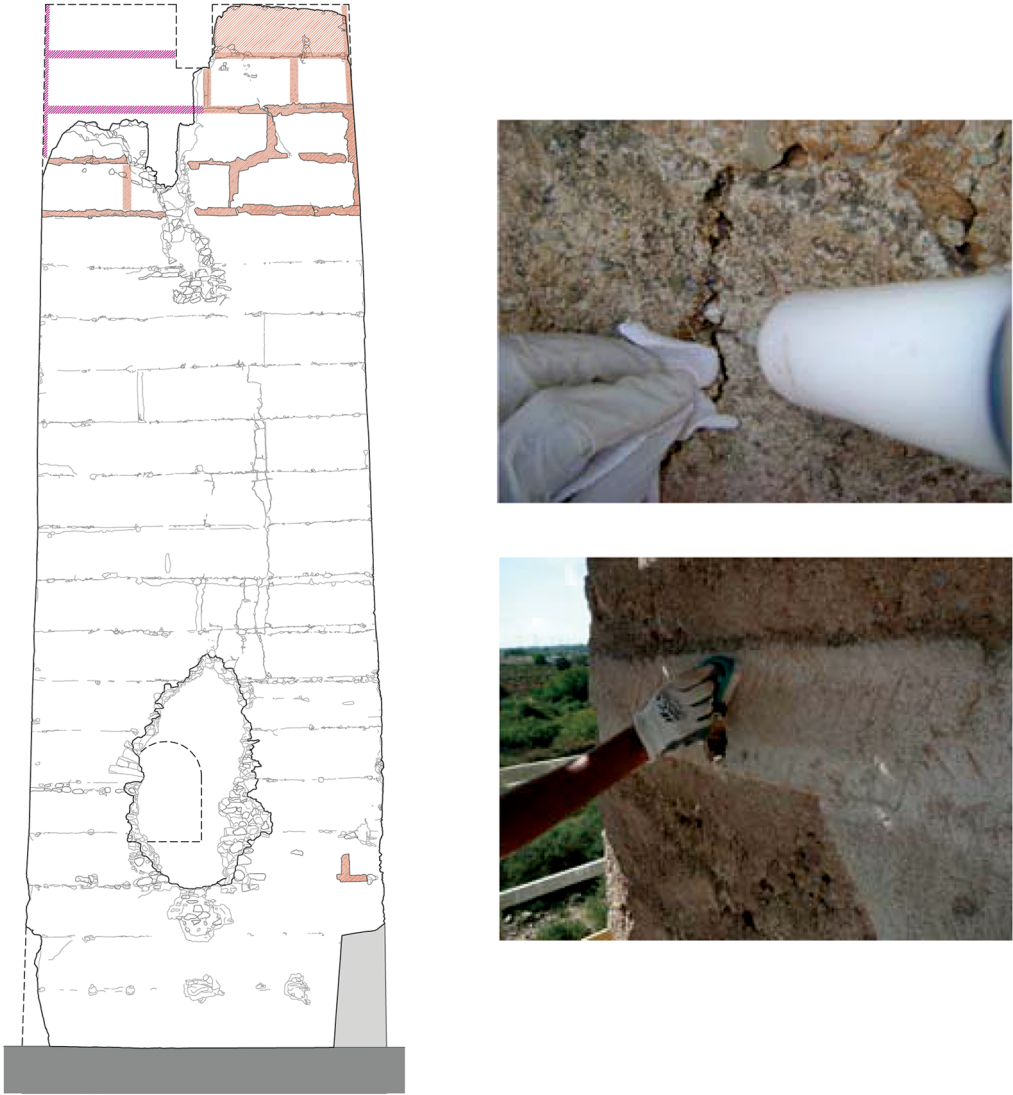
Figure 8. Examples of different consolidation and cleaning techniques (Vegas & Mileto).

The preservation works started by cleaning the surfaces, which had been darkened by the presence of dirt and lichens. Different cleaning techniques were tested, with brushes of different sizes, various bristle materials and a range of detergent products of different intensity of application, always attempting to avoid abrasion of the original crust of the building. After developing various small tests for the cleaning, there emerged reflection about the degree of cleaning that was desired for the preservation of the tower. Deep cleaning would have completely changed the look of the tower and involved partial abrasion of the surfaces. Based on these considerations, the final decision was to clean the surfaces with soft bristle brushes and quaternary ammonium salts as the detergent agent (Figure 8).

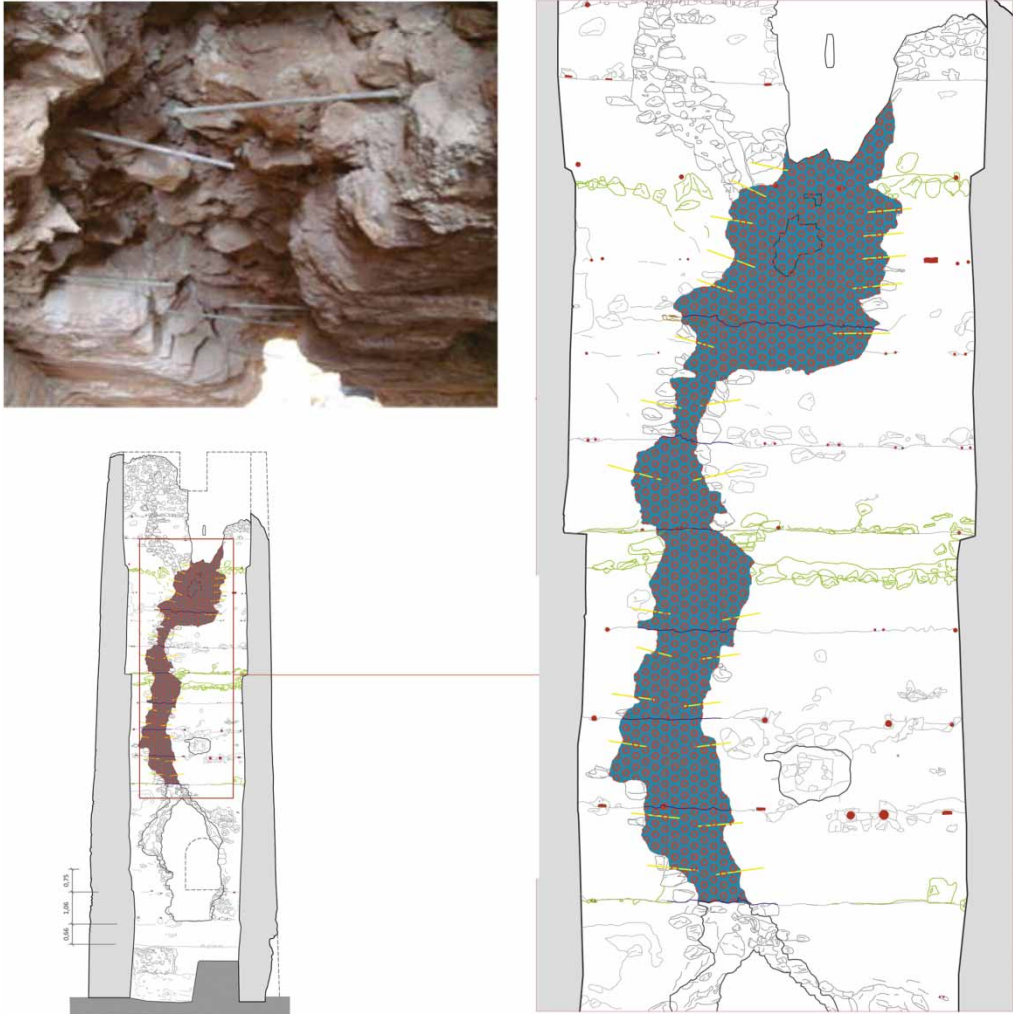
Figure 9. Reintegration of the lacunae, with the insertion of corrugated fibreglass rods to guarantee the connexion of the historic fabrics and the added mass (Vegas & Mileto).

Sometimes the reintegration of volume was important, as in the case of the internal vertical breach on the northern façade. Prior to reintegrating the gaps, it was necessary to insert corrugated fibreglass rods to guarantee the connection of the historic fabrics and the added mass (Figure 9). The state of this particular area was so precarious that the rammed earth fabric needed to be drilled in order to insert the rods, always avoiding percussive work, because that would cause the collapse of building materials and danger to the workers of the building company.
