Restoration of rammed earth architecture in the Iberian Peninsula: Ongoing research

C. Mileto, F. Vegas López-Manzanares, V. Cristini & L. García Soriano

Instituto de Restauración del Patrimonio, Universitat Politècnica de València, Valencia, Spain

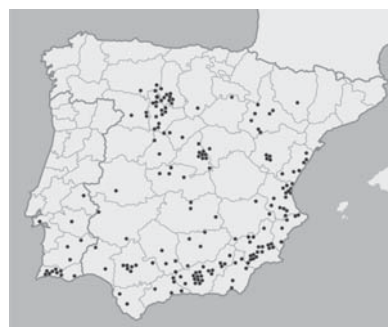
Figure 1. Location of the buildings catalogued up to date and introduced in the data base.

(foundations, structure/walls, cladding, coping, other elements), current state of the intervention (presence of damp, presence of salts, loss of mass, cracks, etc.); intervention criteria. So far 230 buildings located all over the Iberian Peninsula have been recorded (Fig. 1). This number may increase during the course of the research. To compile the files in the database we have drawn from different types of sources, depending on the type of information sought. In the first place, the aim was to identify restored rammed earth buildings scattered all around the peninsula, and, in the second place, to compile a minimum amount of information in the database files so as to be collect the data necessary to catalogue them. All the researchers in the project and the group of scientific collaborators participated, as well as all possible contacts of researchers, professionals, administrations, associations, etc. that could be reached. Furthermore, the lists of the following archives were consulted: the Institute of the Cultural Heritage of Spain, the Ministry of Culture and the Ministry of Development (1% Cultural Plan and the so-called Plan E). At the following stage of the research planned for 2012, the databases of the autonomic administrations will be consulted (Generalitat Valenciana, Junta de Andalucía, Gobierno de Aragón, etc.).

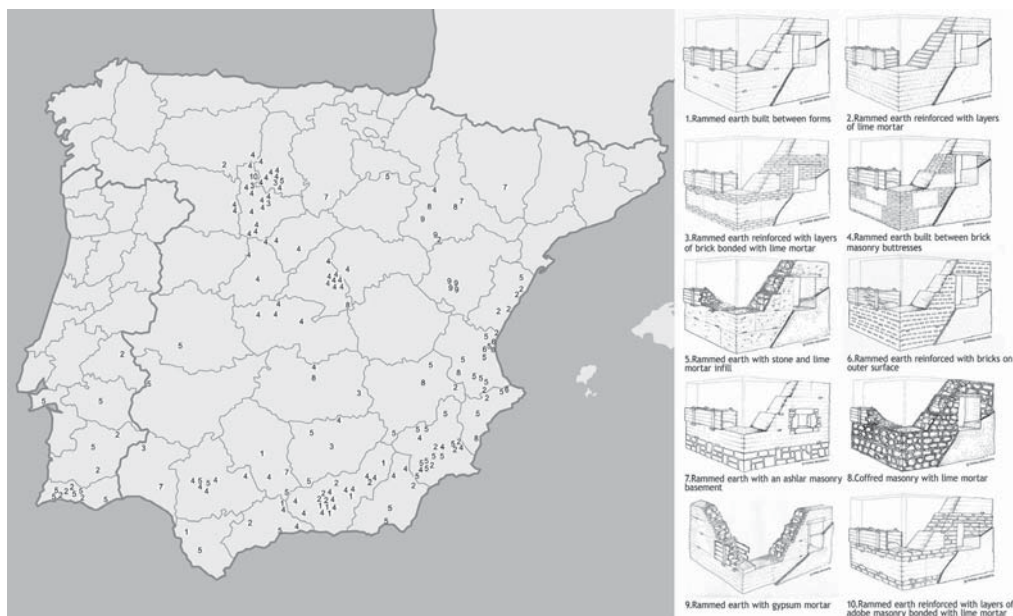
Figure 2. Variants of the rammed earth constructive techniques that appear in the case studies of the data base. (Drawings: Garcia, Cristini, Tibor).

of the building and especially the building technique (rammed earth, lime washed, with *brencas*-undulated reinforcement-, in Valencian style -brick- or stone-reinforced rammed earth-, with added stones, etc), since, depending on the basic building technique, a series of specific problems and pathologies arise and consequently specific intervention criteria and techniques are required (Fig. 2).

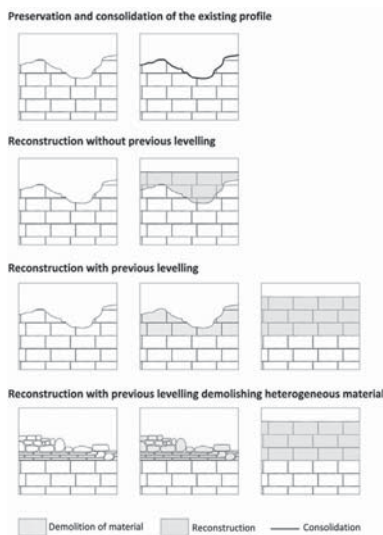
Figure 3. Example of the different constructive techniques found in the studied cases related to the different intervention criteria while building with rammed earth on top of the existing rammed earth wall.

cladding, coping) analyzed according to the aim of the method used (structural consolidation, protection from atmospheric agents or damp, geometric or volumetric recuperation, typology, preparing the building for a new function, etc.), the materials used (traditional materials, new materials, a mixture of traditional and new materials, materials similar to the existing ones, etc.), the type of action (conservation, transformation, elimination, substitution, partial or total reproduction of the existing material, etc.), type of contact relationship (physical connection, mechanical connection, adherence or physicochemical adhesion, etc.). (Fig. 3).
